# Confidential Inspection Report

111 N Old Dr.  
Denver , CO 80202

August 22, 2016

RE: 111 N Old Dr.  
Denver, CO 80202

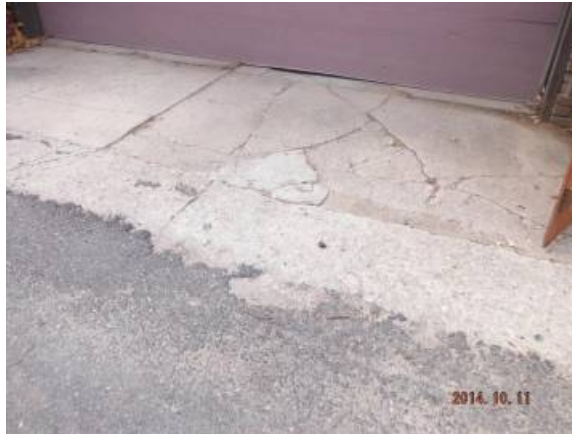
Driveway:

Concrete, Common Cracks, Worn, Nearing in of useful life span, Recommend corrections.

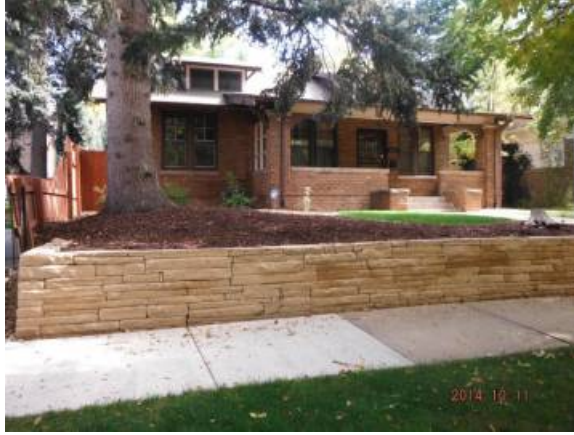
Large tree in front yard, Plants/Trees too close to structure. Removal may be needed, Trees are touching or overhanging the roof. Damage is possible, Recommend corrections to help prevent damage to structure.

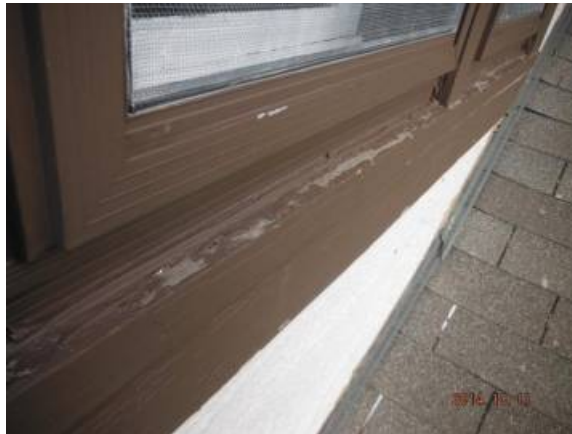
- Wood materials. Metal materials. Serviceable. Paint condition, Paint nearing end of useful life. Recommend paint finish in the near future.

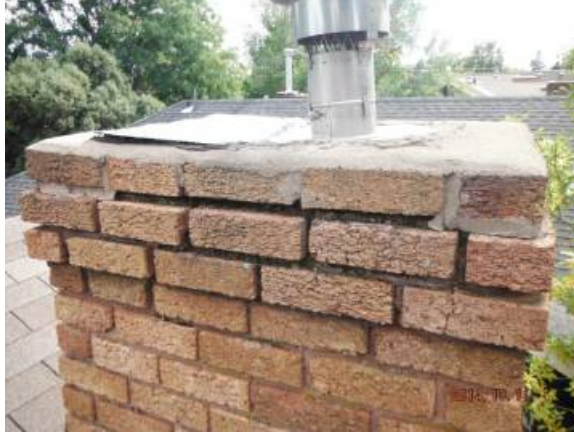
- Two chimneys, Brick materials. Weathering and Aging, Deteriorated mortar, Recommend corrections.

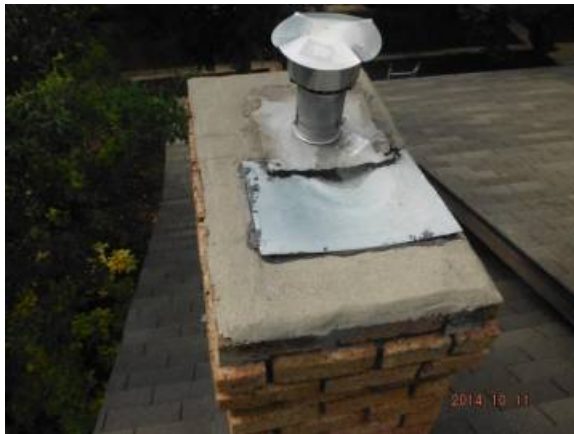
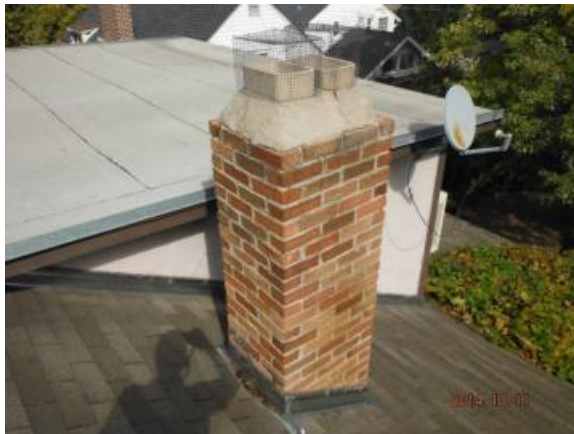
South chimney cap. The chimney cap is made of mortar. Worn, cracks, Deterioration, Recommend corrections so the cap can function as intended and prevent water from entering stack. North chimney There is no metal rain hat installed. It is recommended that one be installed to help prevent rain from entering the flue stack.

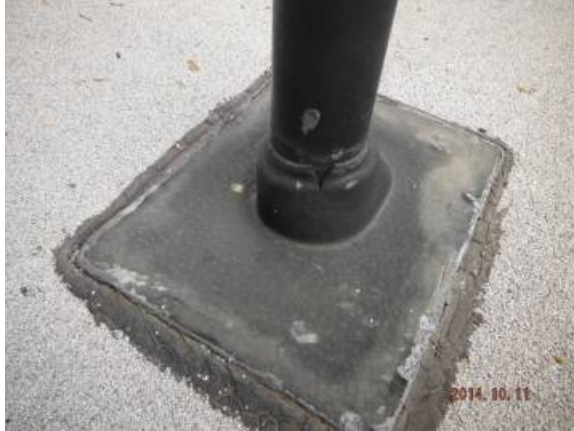
- Observed damage or opening to rubber seal on roof jacks, Recommend corrections or replacement to help prevent moisture from entering into attic. A licensed roofing contractor should be called to make further evaluation and repairs as needed.

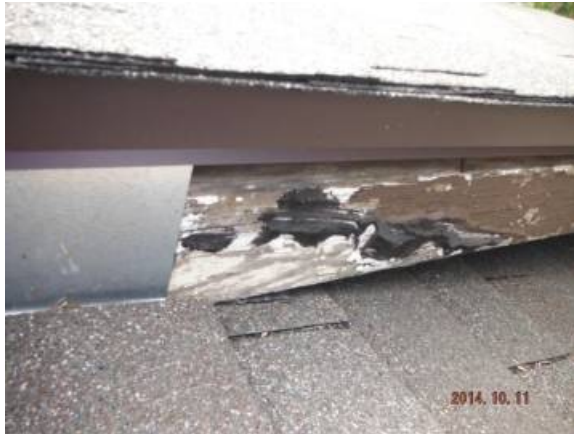
- Wood, Paint condition near the end of useful life. Recommend paint finish in the near future.

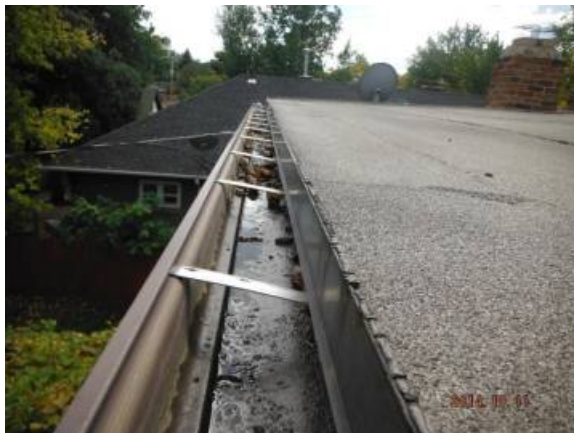
- Metal, Full system, Not functional, Loose, Debris in gutter, Drains blocked, Gutter is sloped improperly and holding water, Recommend correction to help with drainage.

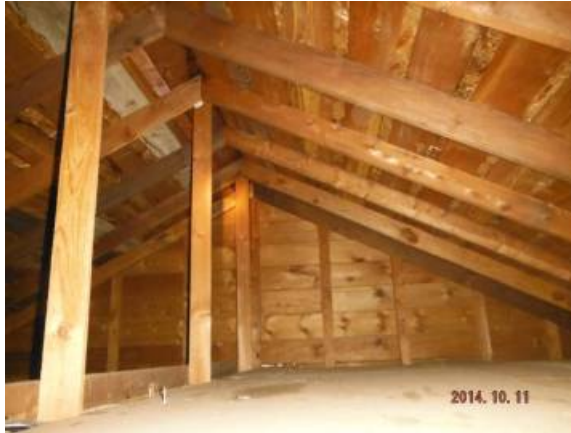
Attic is Full size, Accessible, from bedroom closet. Observed construction debris,

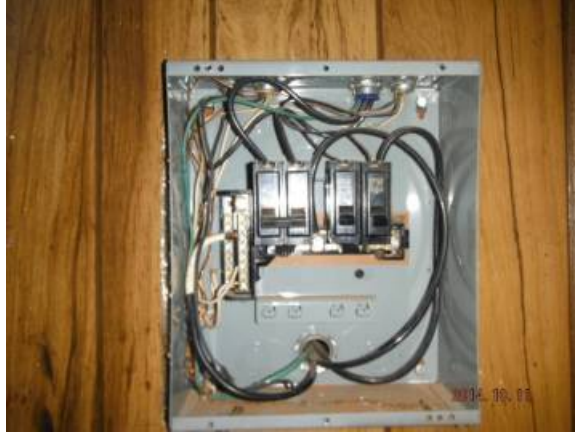
- Located in the Garage, Circuit and wire sizing correct so far as visible, Grounding system is present, Unsafe, Panels are without the benefit of complete labeling, Have a licensed electrician make further evaluation and corrections as needed.

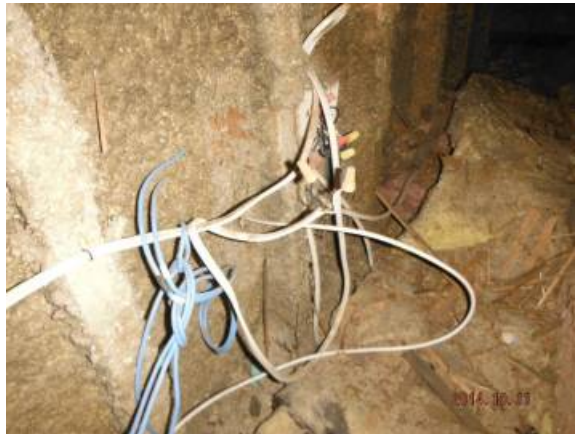
- Copper, Wiring has been altered, Unsafe conditions exist in the attic Connections not made within junction boxes, Open junction boxes are noted, Recommend further evaluation and corrections by licensed electrician.

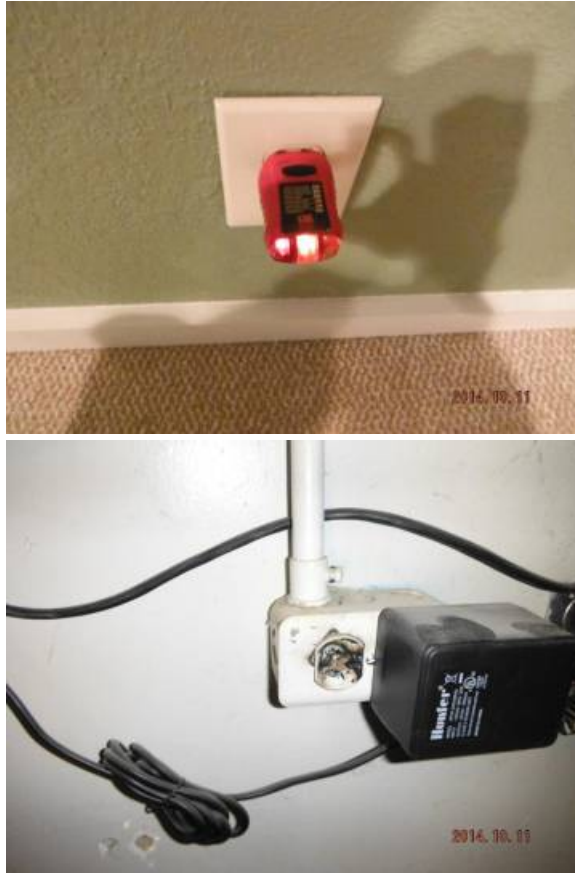
- Missing or damaged cover plates viewed, Reverse polarity is noted, Some grounded type outlets did not appear to be properly grounded. Outlet is not functional Recommend further evaluation and corrections by a licensed electrician.
-

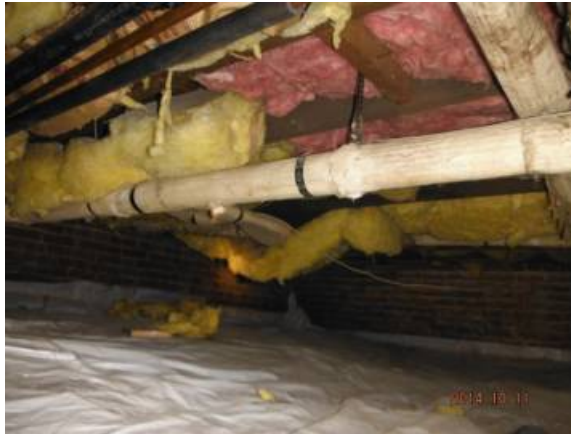
Forced hot water boiler, Noted damaged asbestos insulation on hot water steam pipes in the crawlspace. Recommend further evaluation and corrections by a qualified asbestos abatement contractor.

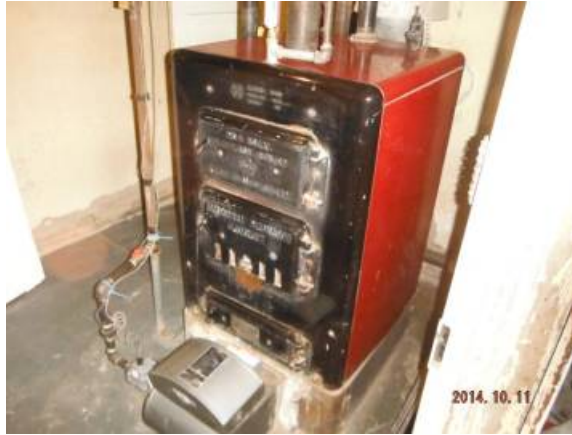
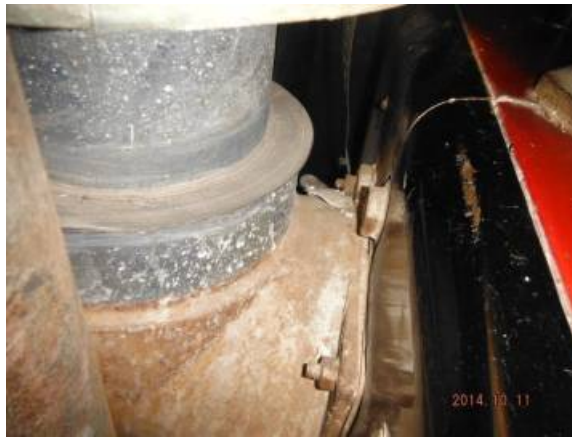
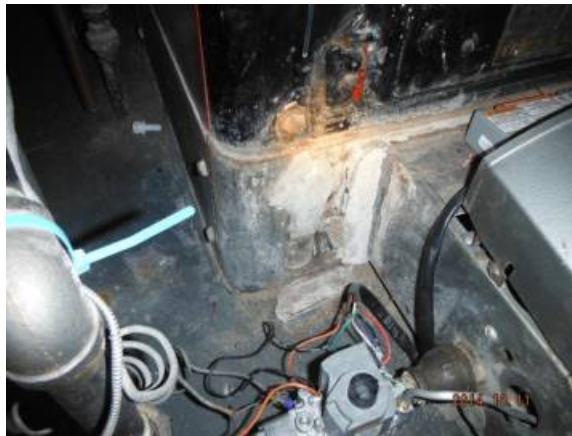
- Operational, Has served it useful life, This system does require maintenance, Recommend complete system evaluation and corrections as needed by a licensed heating and air conditioning contractor. Observed loose asbestos like material near burner intake and on the back side on flue. Evidence that indicates asbestos insulation was removed from steam piping in the basement, leaving behind residue. Recommend further evaluation and corrections by a asbestos abatement contractor.
- 
-

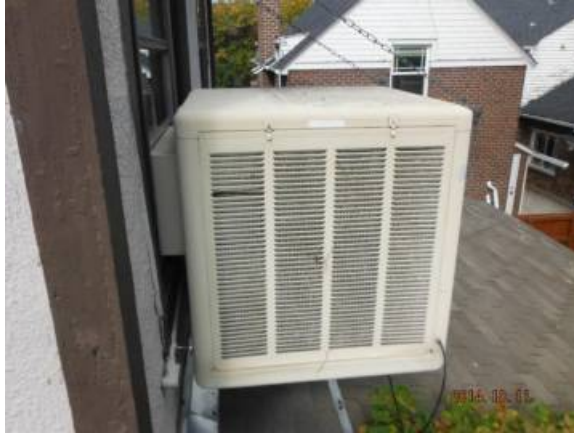
Media within unit is dirty and in need of cleaning. Recommend clean and service health reasons.

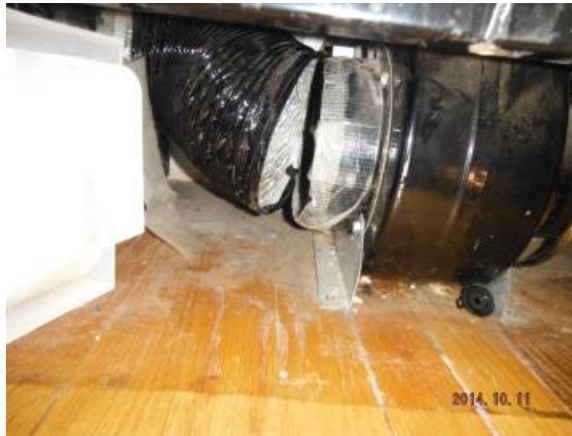
Not functional, Jenn- air vent is disconnected under stove. Recommend repair.

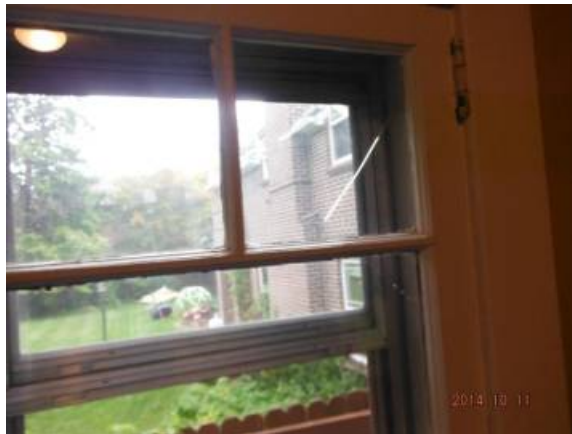
Wood, Casement, Double hung, Some windows are hard to operate or painted closed, worn, Balance or cords cut on the side of sash are causing window to not function properly. Noted cracked or damage glass pane. Recommend further evaluation and corrections by qualified window contractor.

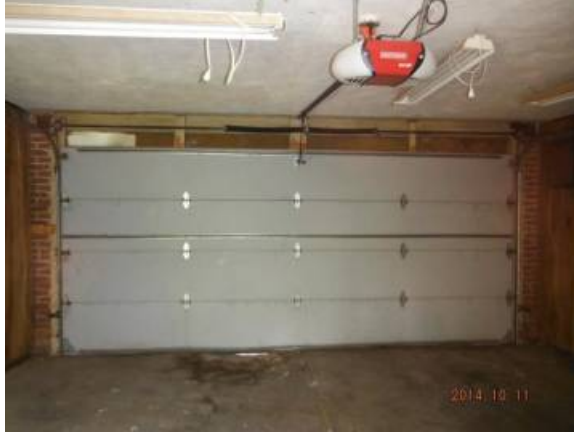
Automatic door opener(s)- operational, Automatic reverse feature is, not operational. Unsafe, Note: All overhead doors should have fully operational auto-reverse function. Door opener tension needs adjustment to insure safe conditions. Recommend correction. Unsafe, Electronic eyes or Sensors, Not installed to manufactures instructions, Sensors or eyes are to be installed 6" to 9" above floor for safety reasons. Recommend corrections.

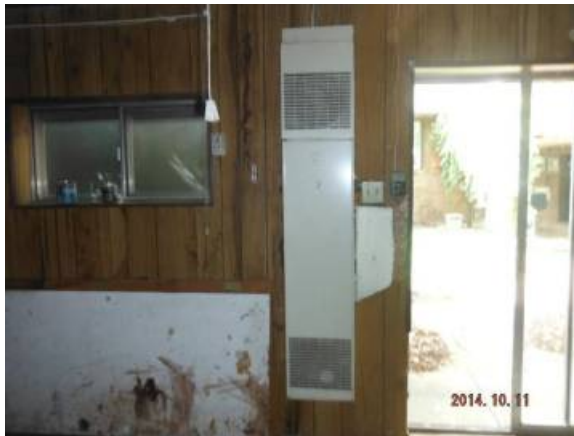
- Exterior service sliding door, Not functional, Latching hardware not functional Door and hardware needs repair for it to function appropriately.

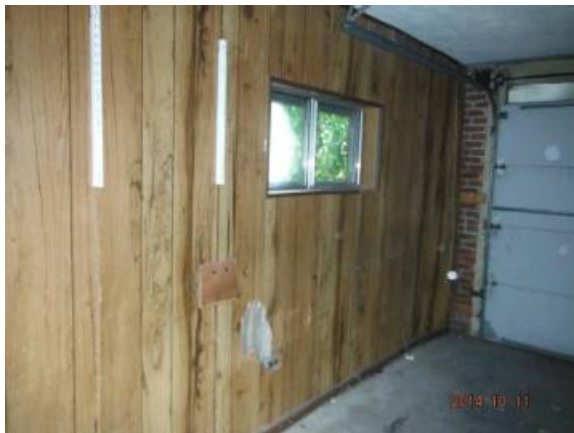
- Wood, Dry moisture stains, warp, Recommend corrections.
