Confidential Inspection Report
321 Unique Way
Englewood , CO 80111

Prepared for: Mr. & Ms Doe

Prepared by: Duane Younger
2090 Matthews Ave
Fort Lupton, CO 80621
720-685-3435

August 16, 2016

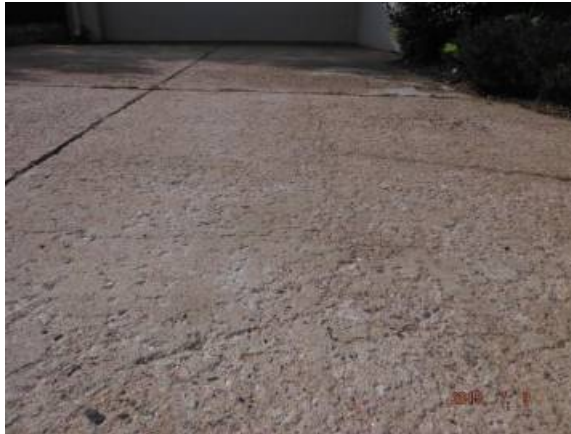
Driveway:

- Concrete, Cracks noted are typical, Spalling noted, Recommend repairs.

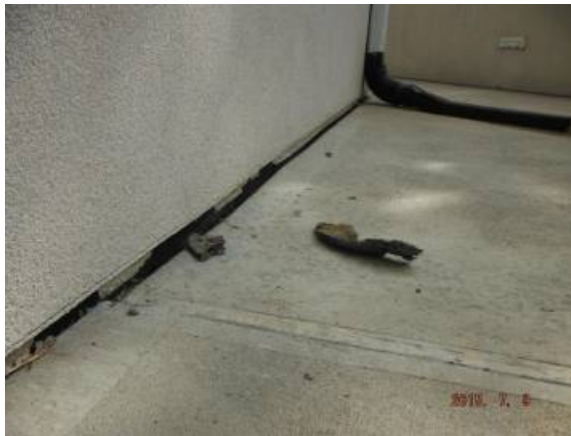
Walks:

- Sidewalk type: Concrete, Several walks around the property, Crack on north walkway, Recommend sealants, Differential Movement, Surface settled, Sloped toward building, Not allowing proper drainage, Observed gaps between exterior foundation wall and walkway. Evidence of deteriorated expansion joint mainly on south east corner and south side of structure. Recommend corrections to prevent any future movement and to help with drainage.

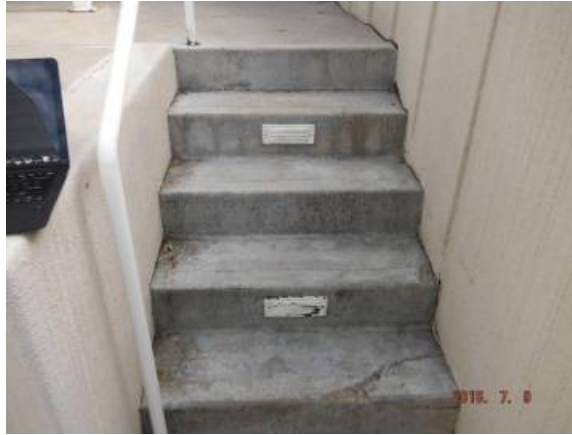
Exterior Steps / Stoops:

- Material: Concrete, North steps, Serviceable. Southeast steps, Cracks, Recommend corrections or sealants.

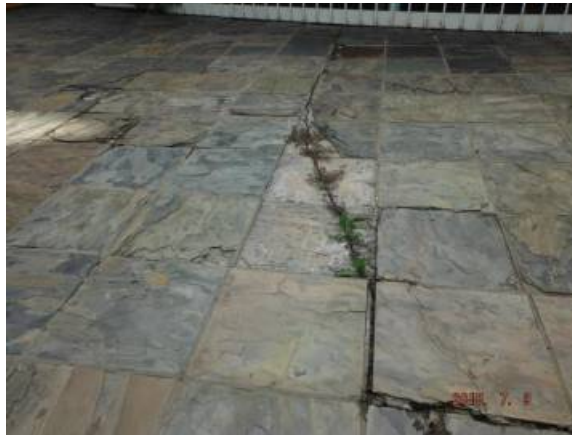
Slab:

Patio type: Patios on the west and south side are Concrete with slate tile covering. Worn, Deterioration and missing tile. East patio from garage, concrete, Common Cracks, expansion joint deterioration. Recommend further evaluation and corrections by a qualified professional. East patio from walkout basement. Concrete, Serviceable.

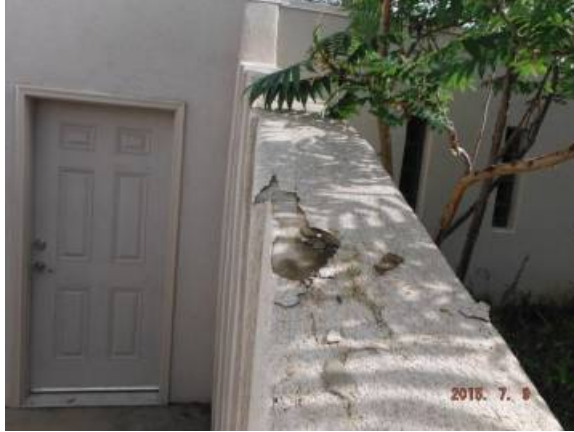
- Retaining wall type: Concrete, stucco covering, Damage/Deteriorated stucco. Recommend further evaluation and corrections as needed by a qualified professional.

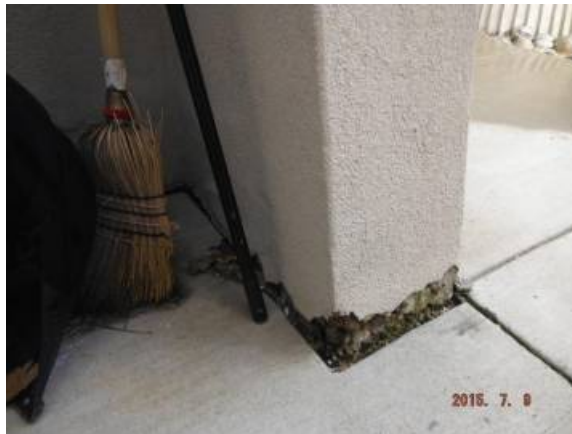
- Walls are constructed with: Concrete, Stucco over concrete, weather and aging, Cracks noted are typical, Note some deterioration at the bottom of the original exterior north front wall. Recommend further evaluation and corrections by qualified professional.

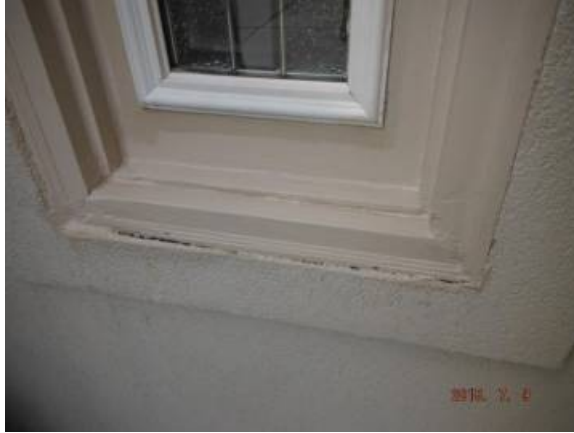
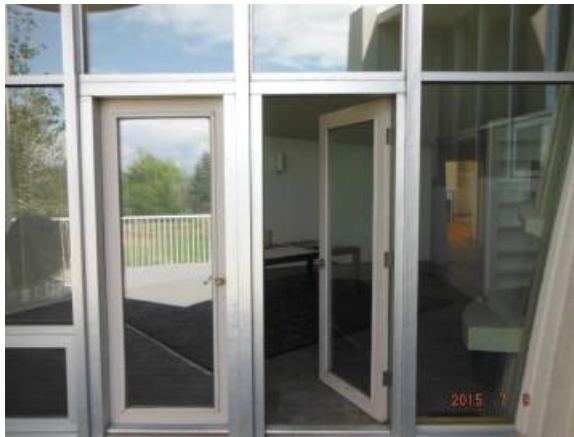
Flashing & Trim:

- Wood materials. Metal materials. Vinyl materials. Evidence of hail damage on west side of structure. Openings and penetrations viewed around windows and doors, Separation in caulking, Recommend sealing openings and penetrations to help prevent water intrusion and future deterioration. Paint condition, Paint nearing end of useful life. Recommend paint finish in the near future.
-

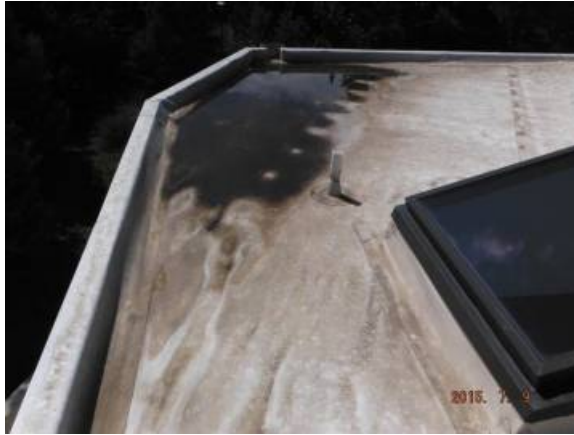
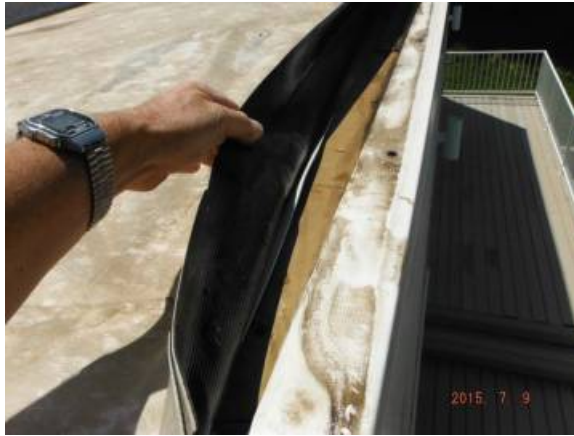
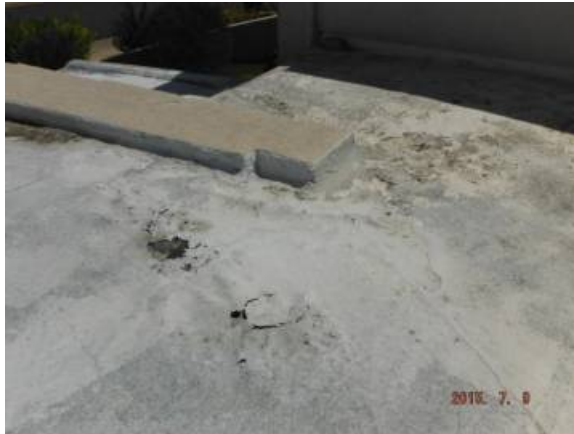
Roof Covering:

Rubber, Sprayed rubber coating over concrete. Weathering and ageing, Damage/Defects noted to roofing material. Blistering, Cracking, Alligating Evidence of ponding, poor drainage Recommend a licensed roofing contractor to make further evaluation and corrections or repairs as needed.

- Rubber, Sprayed rubber coating over concrete. Weathering and ageing, Damage/Defects noted to roofing material. Blistering, Cracking, Alligatoring Evidence of ponding, poor drainage Recommend a licensed roofing contractor to make further evaluation and corrections or repairs as needed.

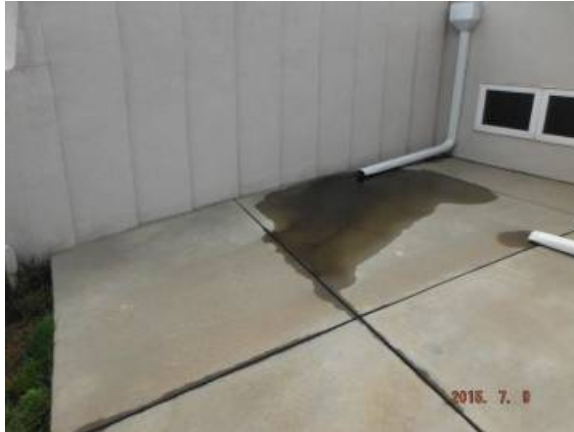
- Metal, Partial system, Improper drainage along the or near north front porch. evidence of water running down between garage wall and concrete porch. Recommend correction to help with proper drainage.

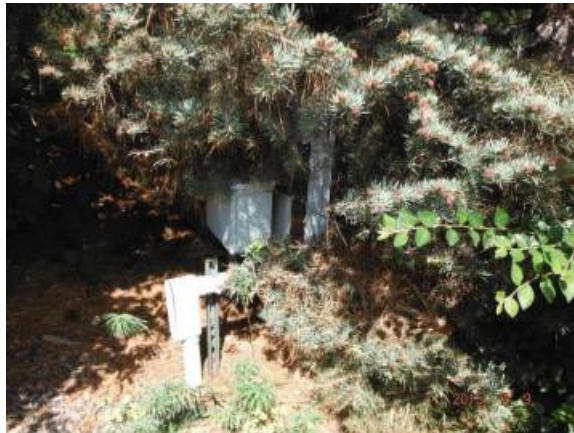
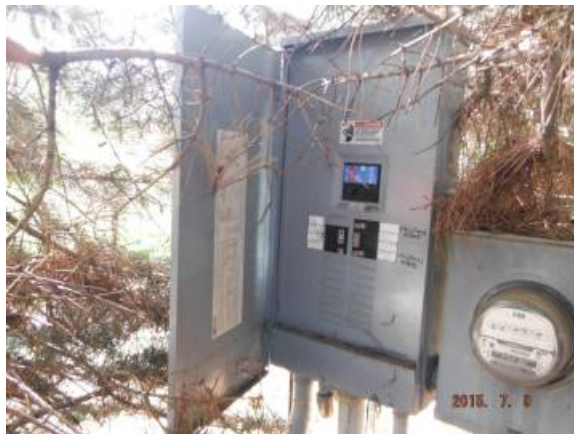
Underground, 240V/120V, 200 amp main disconnect. Unsafe, Does not have 3" clearance around panel. Hazard condition exist, Plant and trees contacting meter and panel. Recommend Further evaluation and corrections by a licensed electrician.

- Underground, 240V/120V, 200 amp main disconnect. Unsafe, Does not have 3" clearance around panel. Hazard condition exist, Plant and trees contacting meter and panel. Recommend Further evaluation and corrections by a licensed electrician.

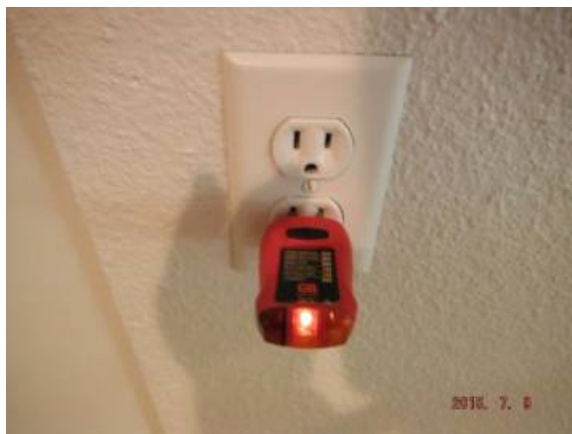
Second bedroom, one grounded type outlet did not appear to be properly grounded. Recommend Corrections.

- Second bedroom, one grounded type outlet did not appear to be properly grounded. Recommend Corrections.

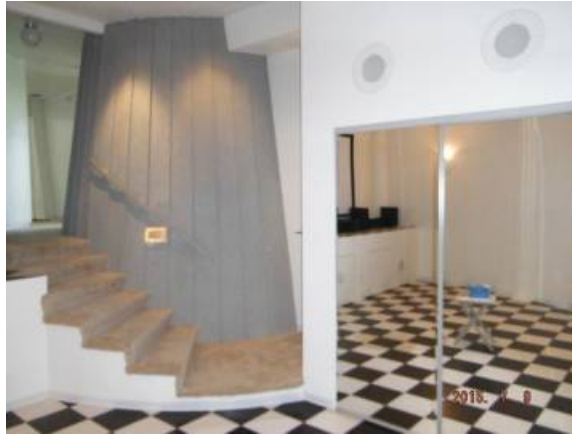
Access:

Basement is fully accessible, Basement is finished. Unsafe, Missing handrail.

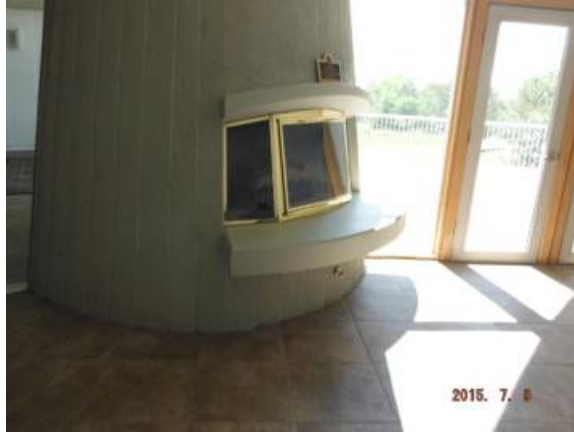
Fireplaces / Solid Fuel Heating:

Master bedroom gas fire place, Serviceable. Lower level family room gas fire place, Not functional, Did not respond to controls, Main living Room gas fire place, Not functional, Did not respond to controls, Main floor family room gas fire place, Not Functional, Did not respond to controls, Basement recreation room gas fire place, not functional, Did not respond to controls. Recommend further evaluation and corrections by a qualified professional.

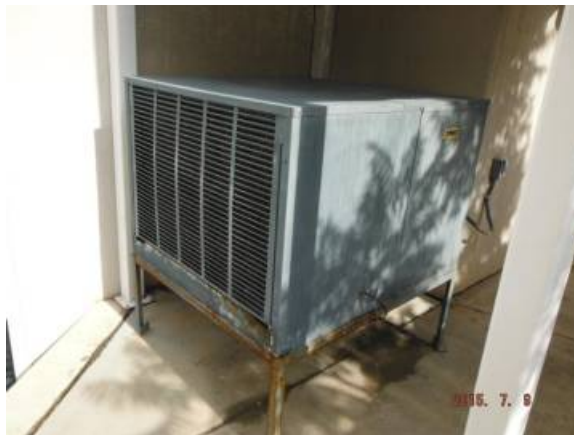
Swamp Cooler:

Industrial Swap cooler, Unable to determine age. Rust/Corrosion noted in cabinet, Media within unit is dirty and in need of cleaning. Deterioration on outside of cabinet, Unit has served its useful life or is nearing it's useful life. Recommend further evaluation and corrections by a qualified professional.

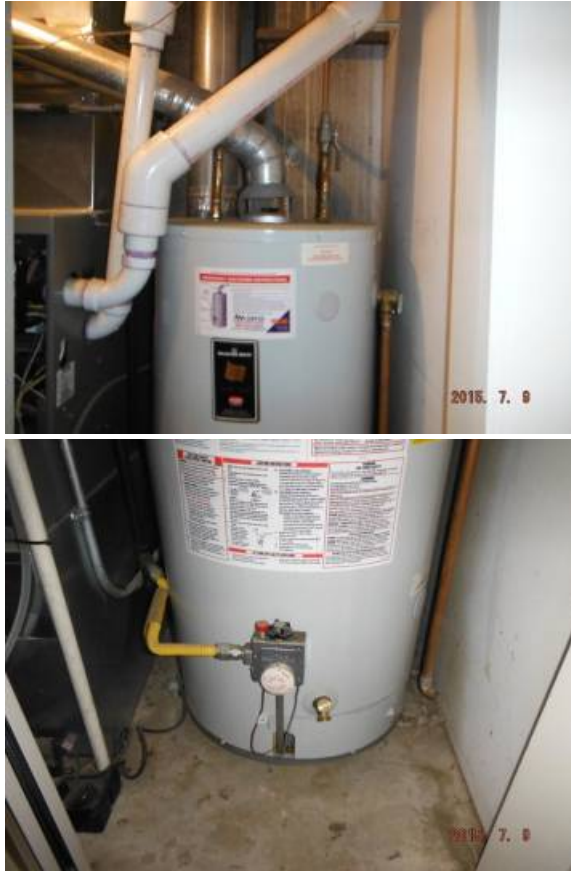
Water Heater # 1

- Rust Flakes are noted, Corrosion is noted, There is evidence of encrustation and/or mineral deposits that may be signs of deterioration. However, no leaks are visible. Older model, Served it's useful life or nearing the end of useful life.

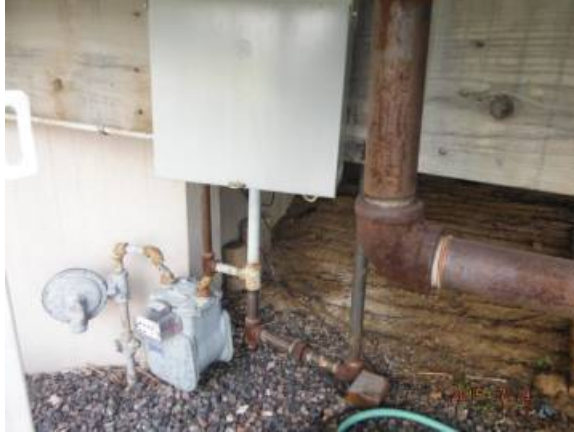
Meter / Tank:

- Meter located at exterior, System Serviceable, Exterior gas piping around gas meter is not corrosion proof. Recommend spray painting to protect iron piping for safety reasons.

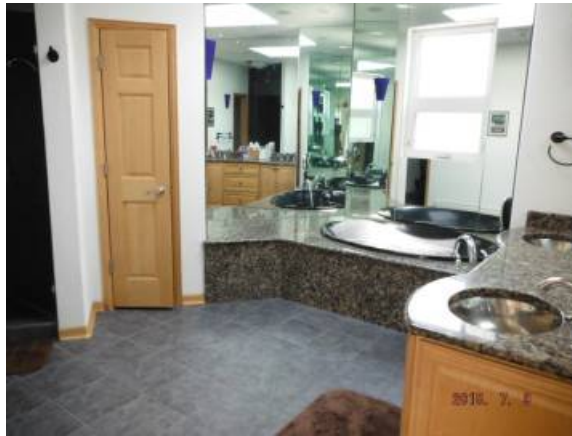
Master Bath:

- Counters/cabinets/Faucets, Serviceable. Right sink, The following problems were noted at the drain: Not functional, Stopper did not operate properly.

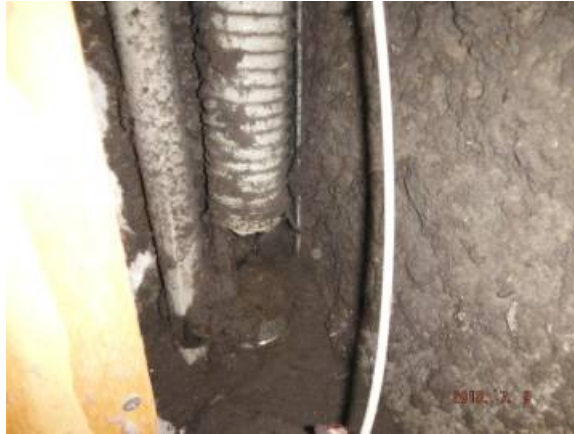
Dryer Vent:

Both areas, A dryer vent is provided to the exterior. Damage to dryer vent located in theater closet. Recommend correction so it can function as intended.

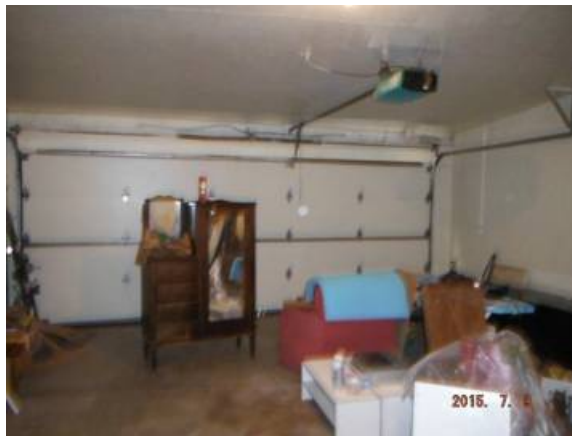
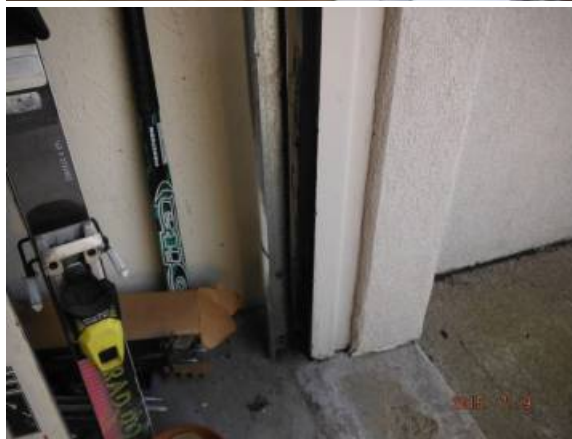
Door Operator:

Automatic reverse feature is, not operational. Unsafe, Note: All overhead doors should have fully operational auto-reverse function. Door opener tension needs adjustment to insure safe conditions. Recommend correction. Unsafe, Missing, Electronic eyes or Sensors, Recommend sensors or electronic eyes to be installed 6" to 9" above floor for safety reasons.

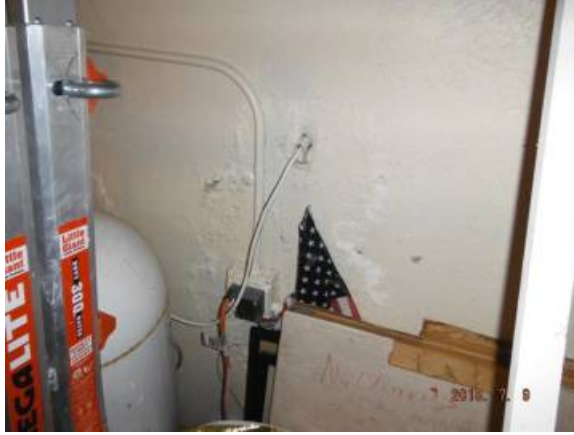
Garage Walls:

Concrete, Moisture damage noted to the northwest wall. Recommend further evaluation and repairs by a qualified professional.
