Confidential Inspection Report

111 N Old Dr.
Denver , CO 80202

Prepared by: Duane Younger
2090 Matthews Ave
Fort Lupton, CO 80621
720-685-3435

August 22, 2016

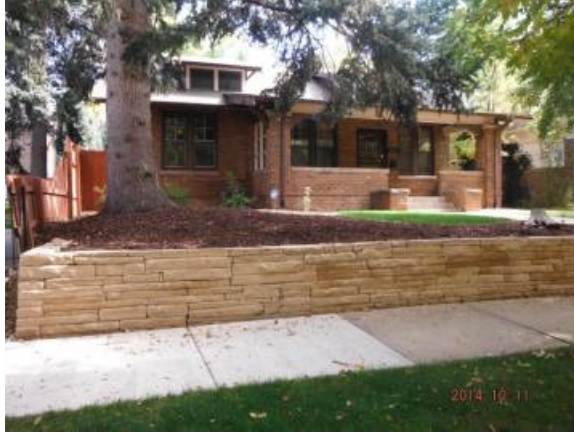
Large tree in front yard, Plants/Trees too close to structure. Removal may be needed, Trees are touching or overhanging the roof. Damage is possible, Recommend corrections to help prevent damage to structure.

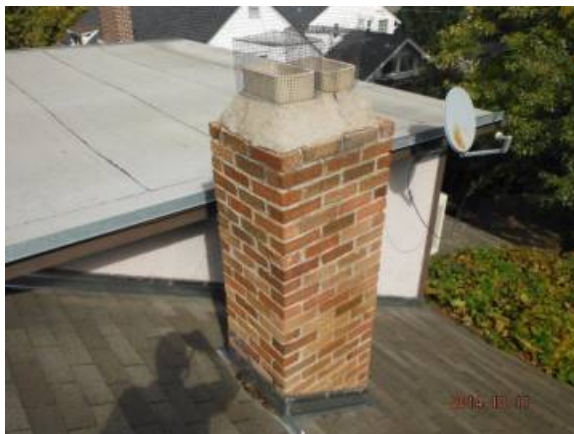
Chimney Cap:

South chimney cap. The chimney cap is made of mortar. Worn, cracks, Deterioration, Recommend corrections so the cap can function as intended and prevent water from entering stack. North chimney There is no metal rain hat installed. It is recommended that one be installed to help prevent rain from entering the flue stack.

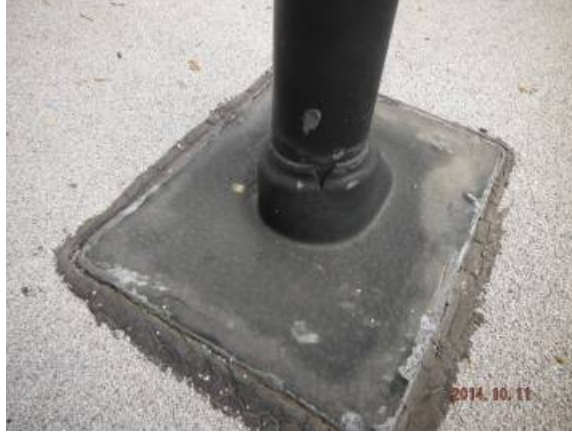
- Observed damage or opening to rubber seal on roof jacks, Recommend corrections or replacement to help prevent moisture from entering into attic. A licensed roofing contractor should be called to make further evaluation and repairs as needed.

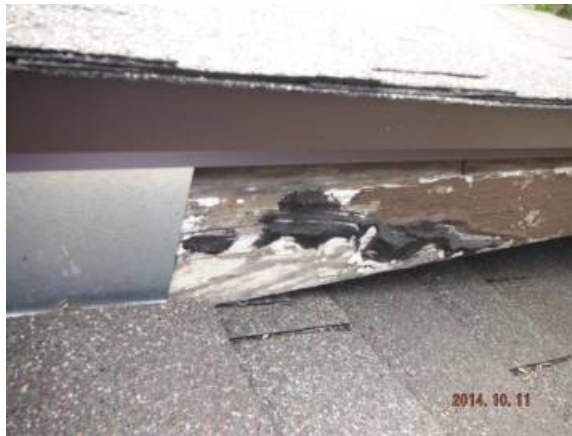
- Wood, Paint condition near the end of useful life. Recommend paint finish in the near future.

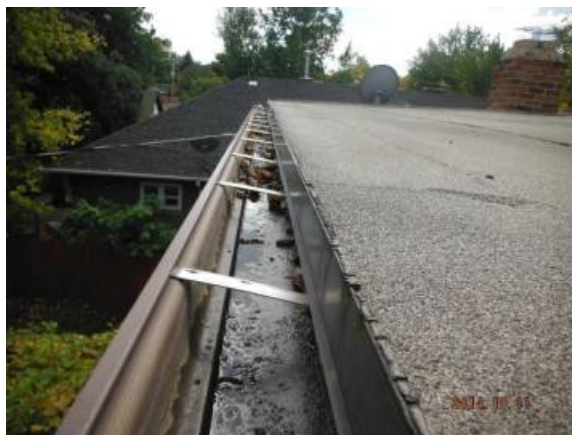
Gutters & Downspouts:

- Metal, Full system, Not functional, Loose, Debris in gutter, Drains blocked, Gutter is sloped improperly and holding water, Recommend correction to help with drainage.

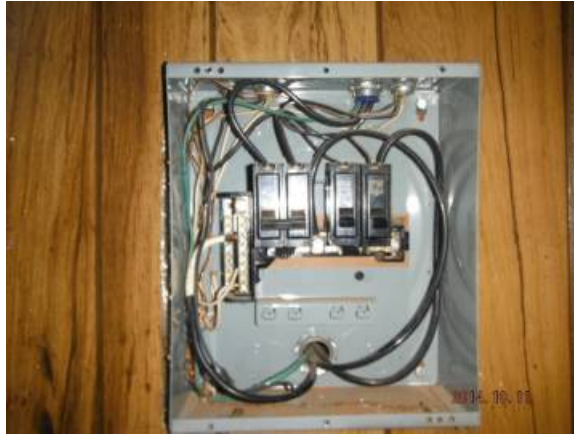
Subpanel #1:

- Located in the Garage, Circuit and wire sizing correct so far as visible, Grounding system is present, Unsafe, Panels are without the benefit of complete labeling, Have a licensed electrician make further evaluation and corrections as needed.

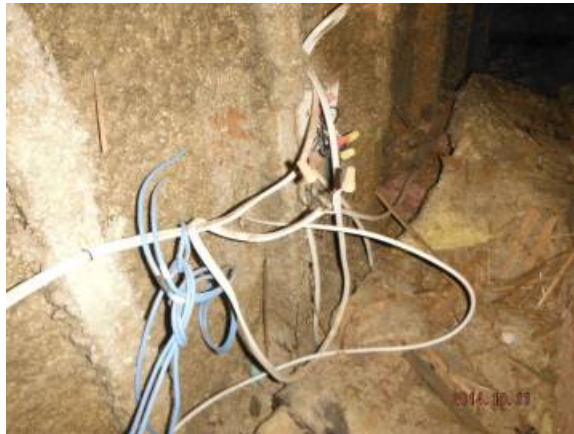
Branch Wiring:

- Copper, Wiring has been altered, Unsafe conditions exist in the attic Connections not made within junction boxes, Open junction boxes are noted, Recommend further evaluation and corrections by licensed electrician.

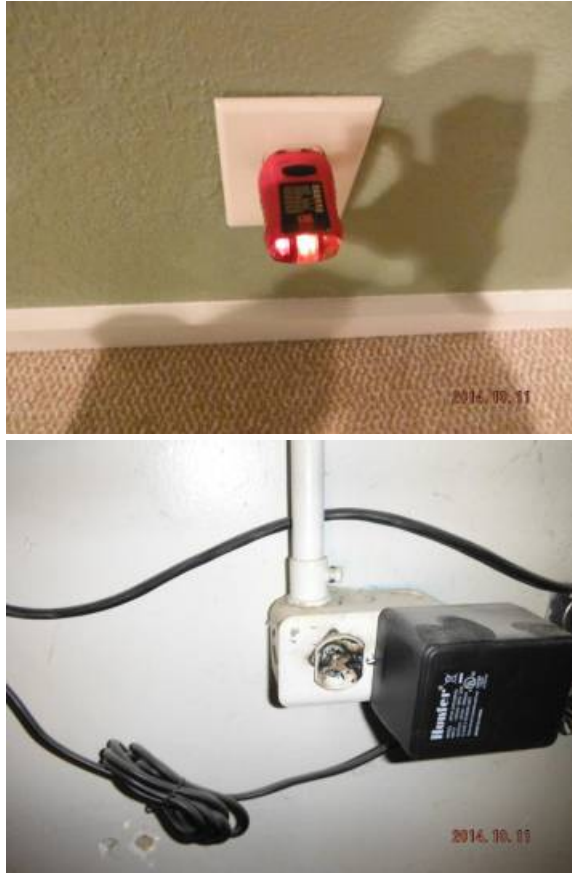
- Missing or damaged cover plates viewed, Reverse polarity is noted, Some grounded type outlets did not appear to be properly grounded. Outlet is not functional Recommend further evaluation and corrections by a licensed electrician.
-

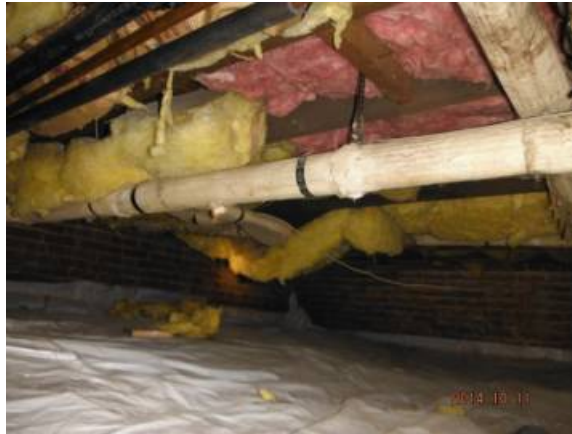
Forced hot water boiler, Noted damaged asbestos insulation on hot water steam pipes in the crawlspace. Recommend further evaluation and corrections by a qualified asbestos abatement contractor.

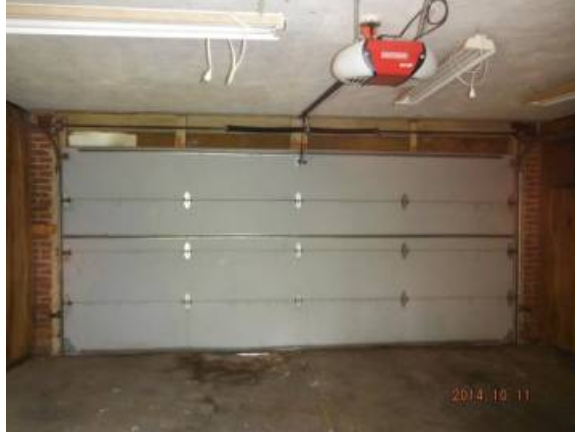
Door Operator:

Automatic door opener(s)- operational, Automatic reverse feature is, not operational. Unsafe, Note: All overhead doors should have fully operational auto-reverse function. Door opener tension needs adjustment to insure safe conditions. Recommend correction. Unsafe, Electronic eyes or Sensors, Not installed to manufactures instructions, Sensors or eyes are to be installed 6" to 9" above floor for safety reasons. Recommend corrections.

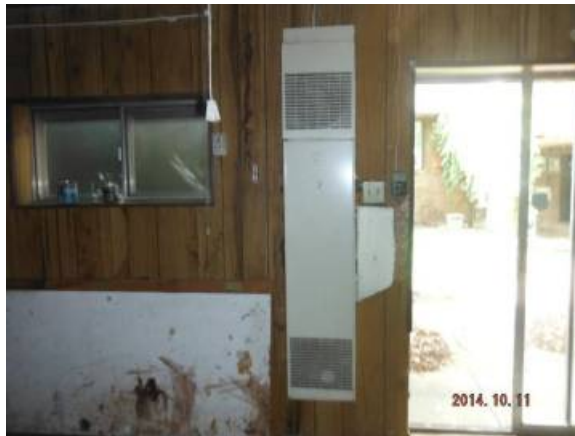
- Exterior service sliding door, Not functional, Latching hardware not functional Door and hardware needs repair for it to function appropriately.

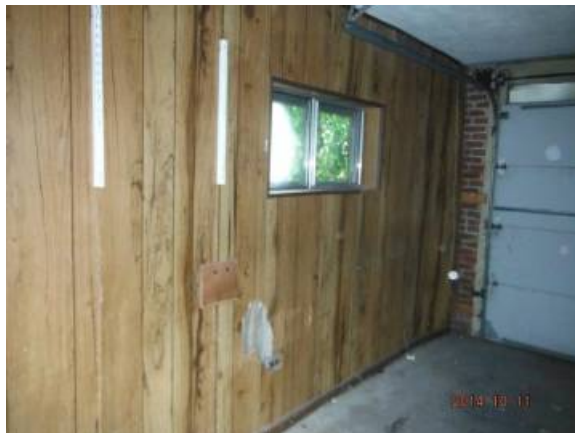
Garage Walls:

- Wood, Dry moisture stains, warp, Recommend corrections.
