Confidential Inspection Report
321 Unique Way
Englewood , CO 80111

Prepared for: Mr. & Ms Doe

Prepared by: Duane Younger
2090 Matthews Ave
Fort Lupton, CO 80621
720-685-3435

August 16, 2016

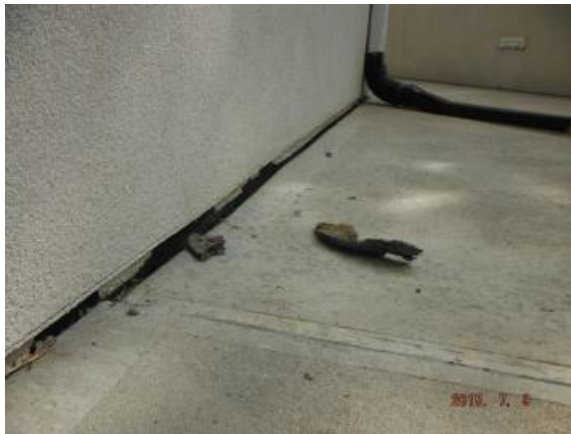
Walks:

- Sidewalk type: Concrete, Several walks around the property, Crack on north walkway, Recommend sealants, Differential Movement, Surface settled, Sloped toward building, Not allowing proper drainage, Observed gaps between exterior foundation wall and walkway. Evidence of deteriorated expansion joint mainly on south east corner and south side of structure. Recommend corrections to prevent any future movement and to help with drainage.

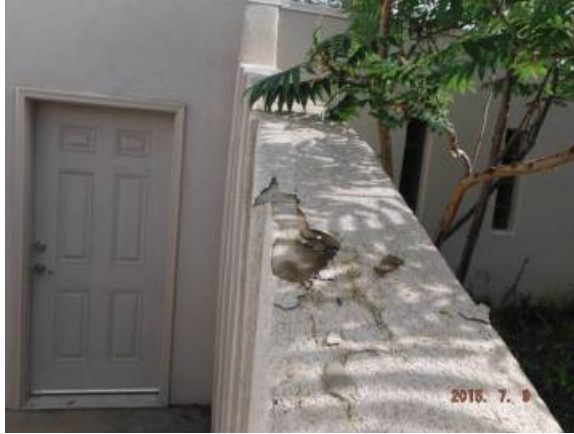
- Retaining wall type: Concrete, stucco covering, Damage/Deteriorated stucco. Recommend further evaluation and corrections as needed by a qualified professional.

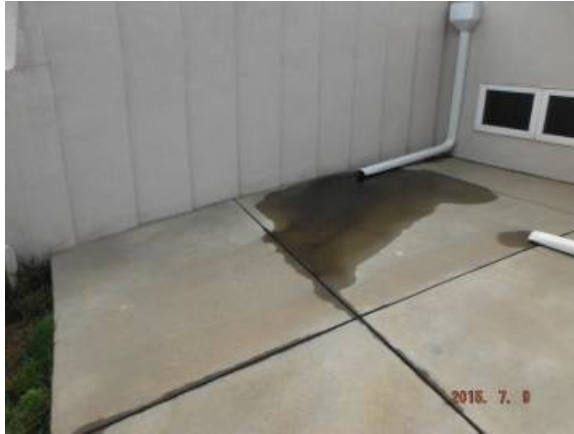
- Metal, Partial system, Improper drainage along the or near north front porch. evidence of water running down between garage wall and concrete porch. Recommend correction to help with proper drainage.

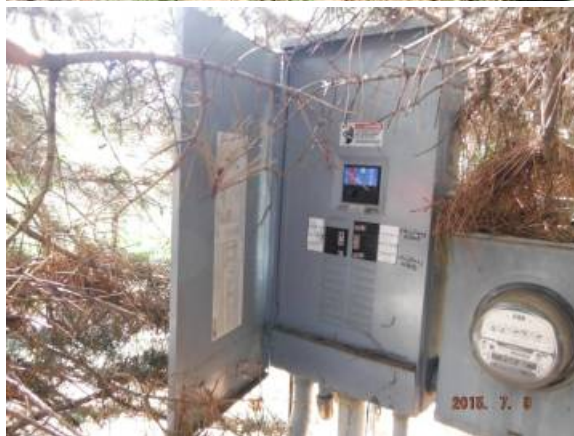
- Underground, 240V/120V, 200 amp main disconnect. Unsafe, Does not have 3" clearance around panel. Hazard condition exist, Plant and trees contacting meter and panel. Recommend Further evaluation and corrections by a licensed electrician.

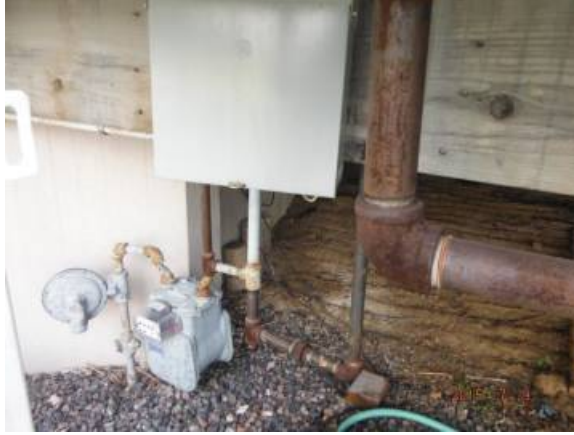
Meter / Tank:

- Meter located at exterior, System Serviceable, Exterior gas piping around gas meter is not corrosion proof. Recommend spray painting to protect iron piping for safety reasons.

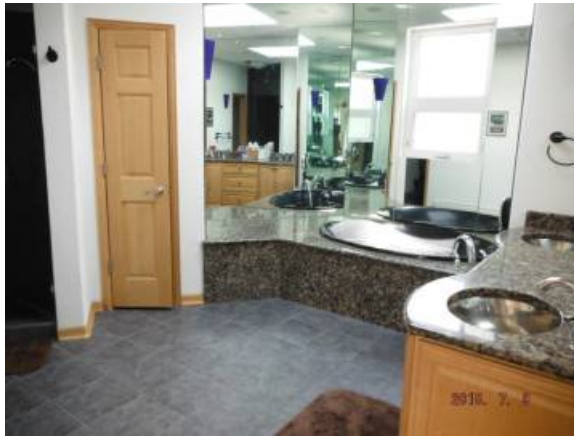
Master Bath:

- Counters/cabinets/Faucets, Serviceable. Right sink, The following problems were noted at the drain: Not functional, Stopper did not operate properly.

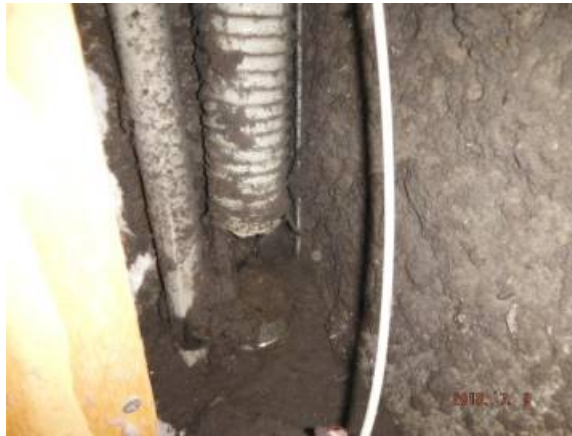
Dryer Vent:

Both areas, A dryer vent is provided to the exterior. Damage to dryer vent located in theater closet. Recommend correction so it can function as intended.

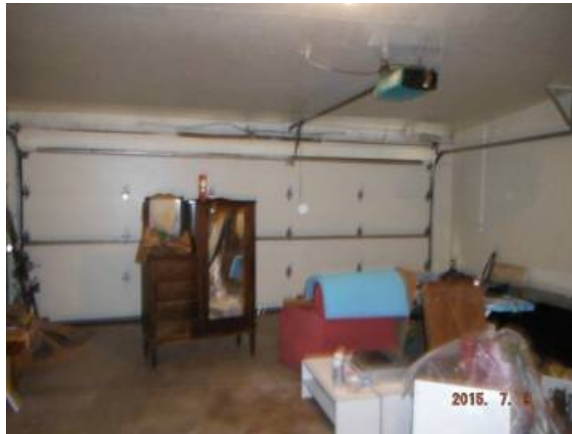
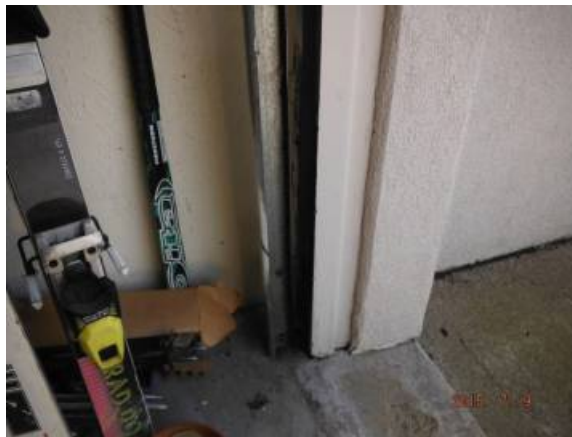
Door Operator:

Automatic reverse feature is, not operational. Unsafe, Note: All overhead doors should have fully operational auto-reverse function. Door opener tension needs adjustment to insure safe conditions. Recommend correction. Unsafe, Missing, Electronic eyes or Sensors, Recommend sensors or electronic eyes to be installed 6" to 9" above floor for safety reasons.
