Confidential Inspection Report
321 Unique Way
Englewood , CO 80111

Prepared for: Mr. & Ms Doe

Prepared by: Duane Younger
2090 Matthews Ave
Fort Lupton, CO 80621
720-685-3435

August 16, 2016

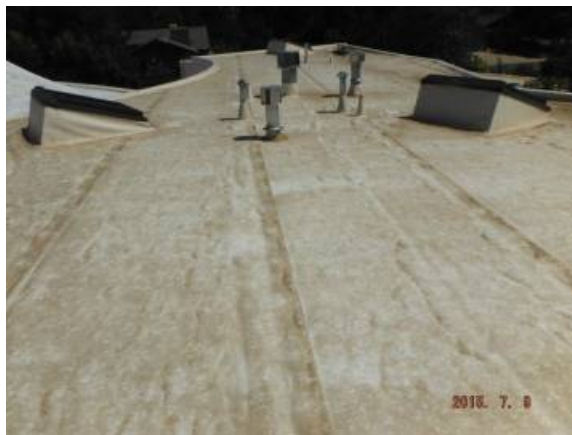
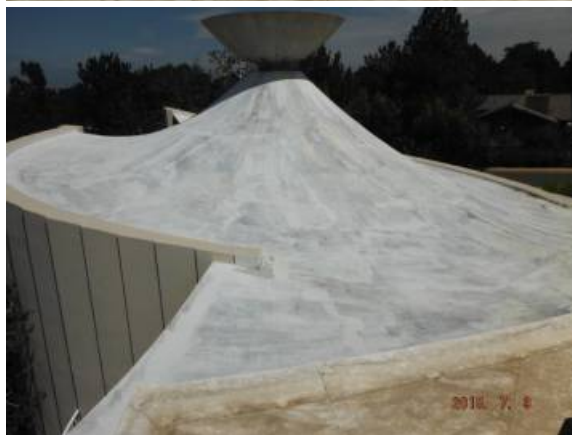
Roof Access:

Walked on roof.

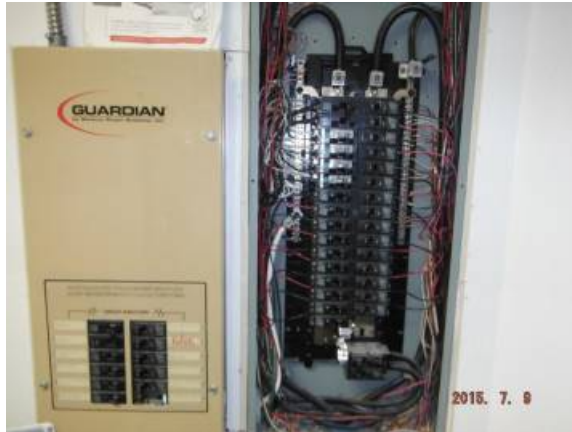
Subpanel #1:

- 100 amp panel. Located in the laundry room closet. Circuit and wire sizing correct so far as visible, Grounding system is present.

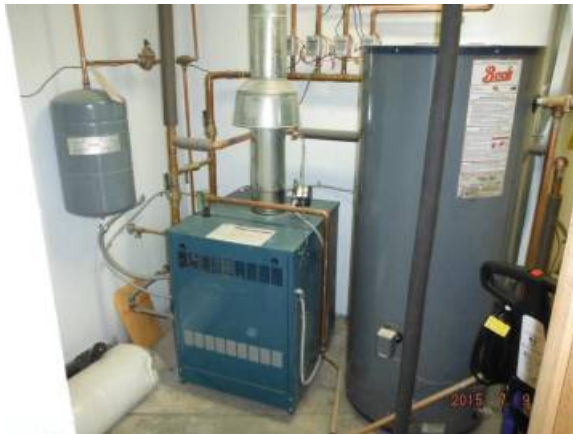
Type & Location:

Forced hot water boiler, Water Storage Tank, Circulating pumps, located north end in basement closet.

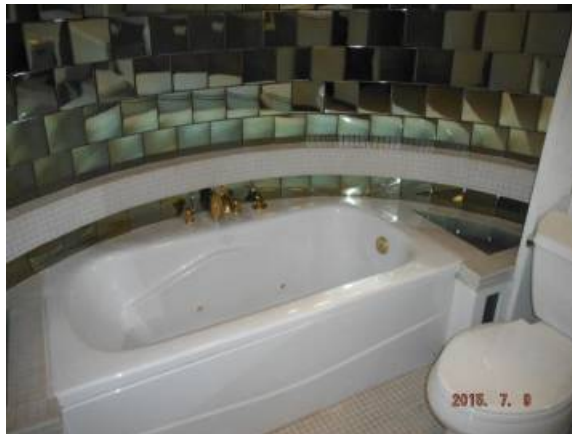
Guest Bedroom Bath:

Tub/Shower walls, Serviceable.

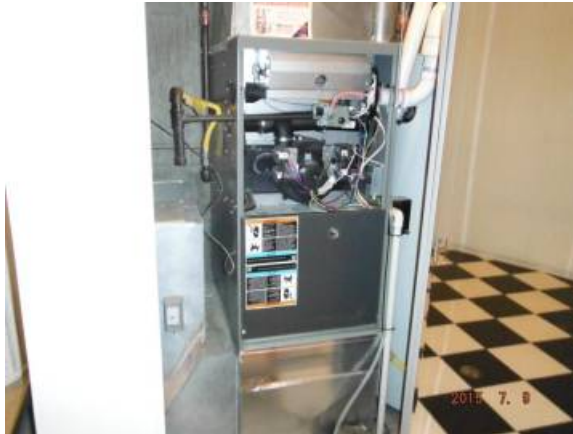
Type & Location:

Forced Air, The furnace is a very high efficiency type furnace using a fan to push the burnt exhaust gases out of the plastic flue pipe.
Location: Basement.

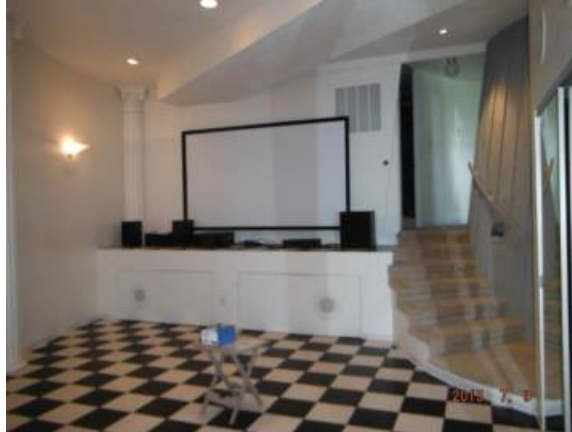
Number Of Sampling Units Set:

Three continuous monitors. Basement master bedroom, Middle basement bedroom, Lower Theater room. Femto- tech CRM510-5800, 6334, 5603,
