Confidential Inspection Report
321 Unique Way
Englewood , CO 80111

Prepared for: Mr. & Ms Doe

Prepared by: Duane Younger
2090 Matthews Ave
Fort Lupton, CO 80621
720-685-3435

August 16, 2016

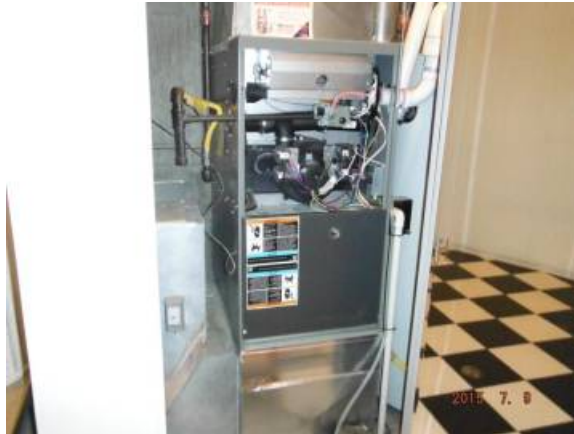
Type & Location:

Forced Air, The furnace is a very high efficiency type furnace using a fan to push the burnt exhaust gases out of the plastic flue pipe.
Location: Basement.

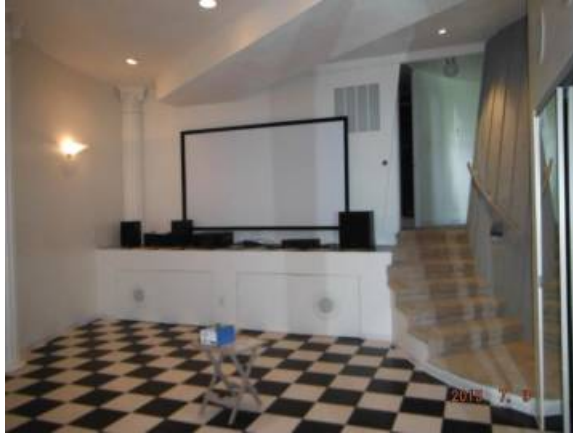
Number Of Sampling Units Set:

Three continuous monitors. Basement master bedroom, Middle basement bedroom, Lower Theater room. Femto- tech CRM510-5800, 6334, 5603,
